GEOTECHNICAL ENGINEERING REPORT

ECP Gate 3 Apron – Limited Existing Pavement Evaluation Bay County, Florida

NOVA Project Number: 7216101r1

Subject: Report of Limited Existing Pavement Evaluation
ECP GATE 3 APRON
Bay County, Florida
NOVA Project Number 7216101r1

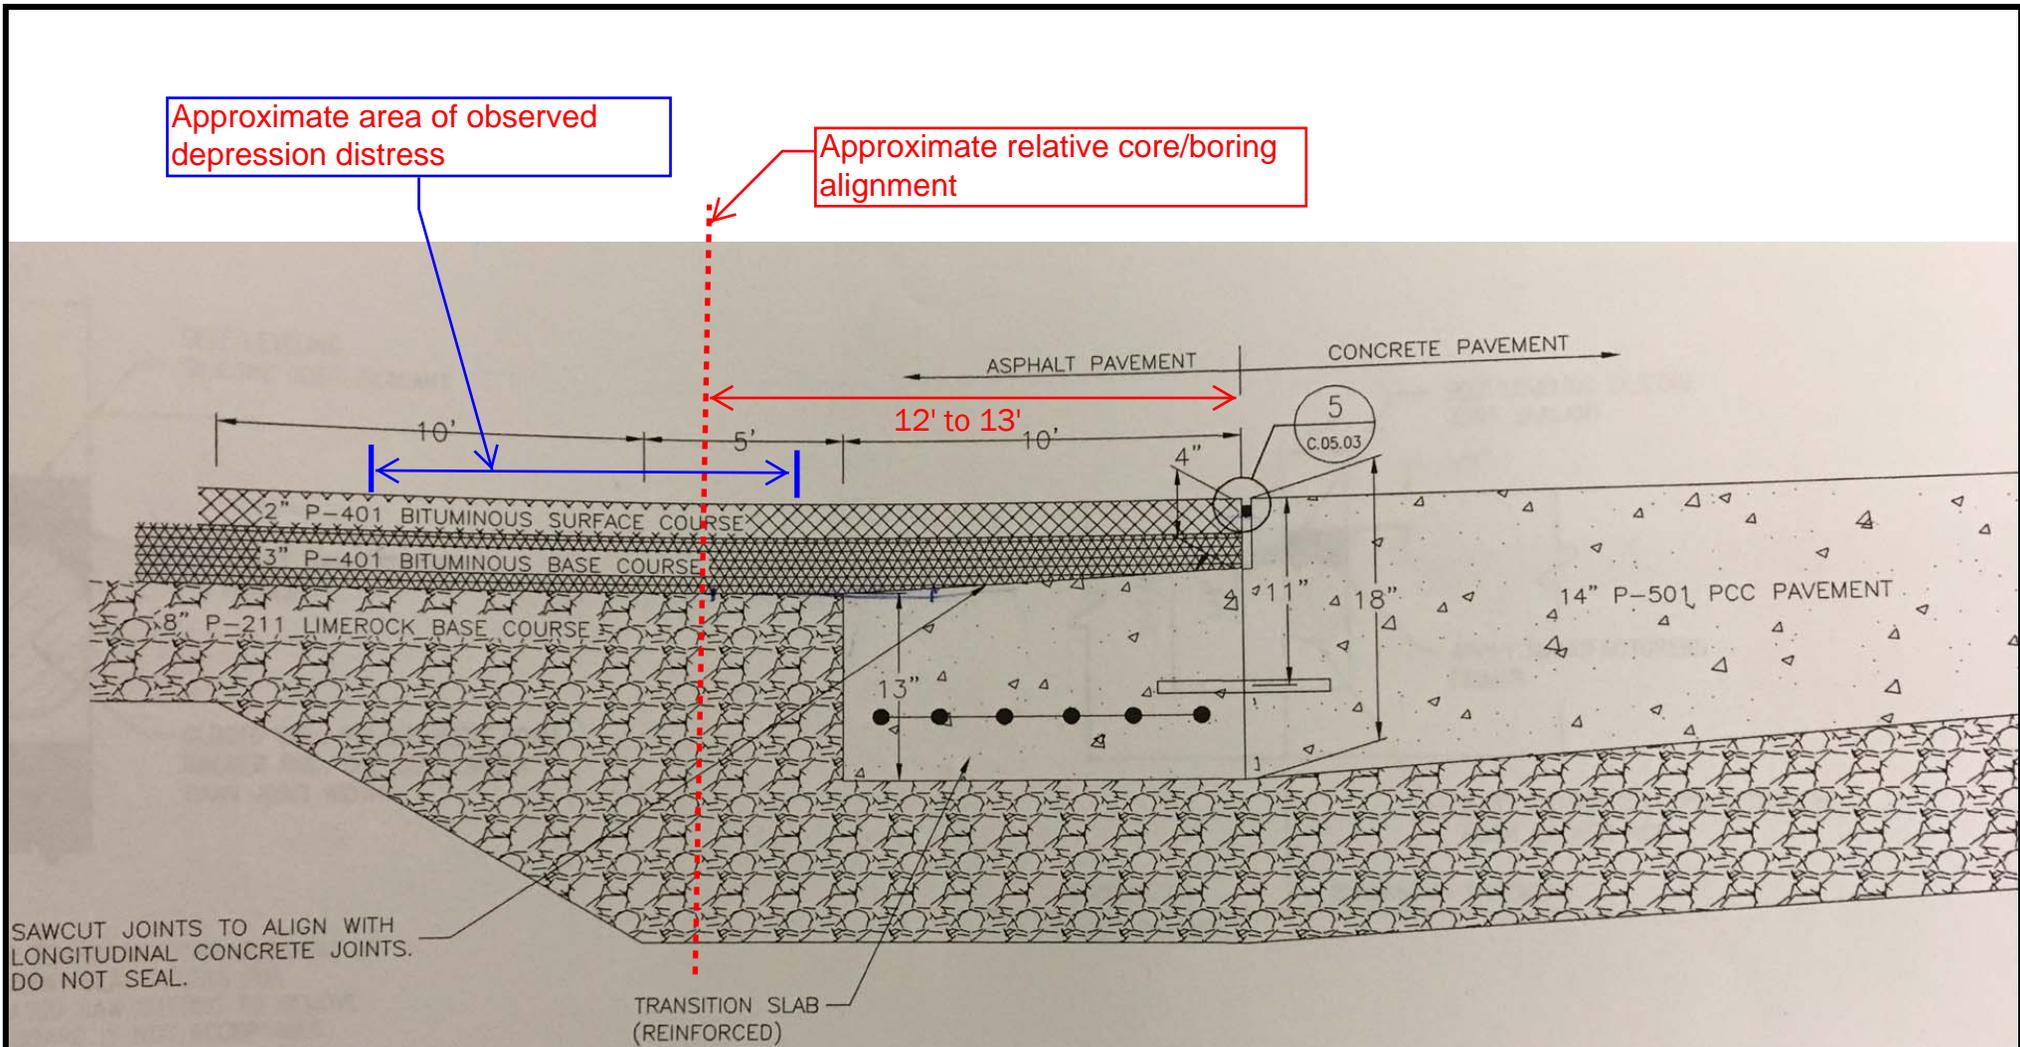
TYPICAL PAVEMENT SECTION DETAIL
ECP Gate 3 Apron – Limited Existing Pavement Evaluation
 Panama City, Bay County, Florida
 NOVA Project Number 7216101r1

Based on the cores/borings performed, the existing pavement section comprises approximately 5-inches of asphaltic concrete underlain by 12½ inches to 16 inches of limerock base material. Based on the aforementioned provided design pavement section detail prepared by PBS&J, the asphaltic concrete layer observed appears to meet the project design requirements; however, the design limerock base thickness was specified to be approximately 21 inches thick at the core/boring locations.

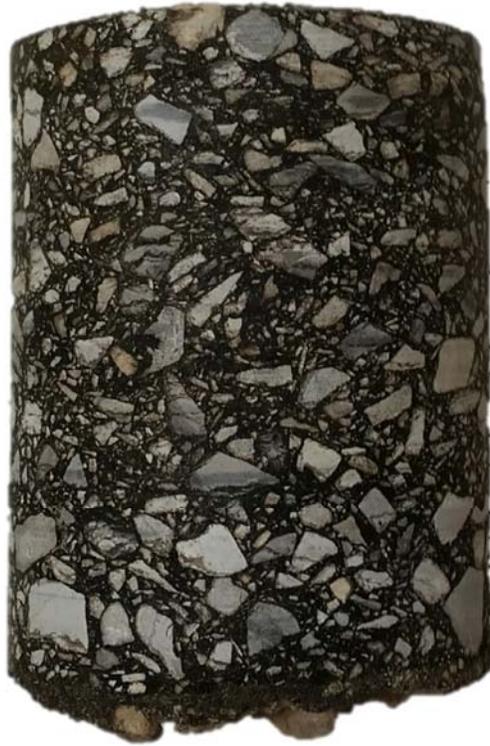
Photo of the 5 inch thick pavement core obtained at C-1 location

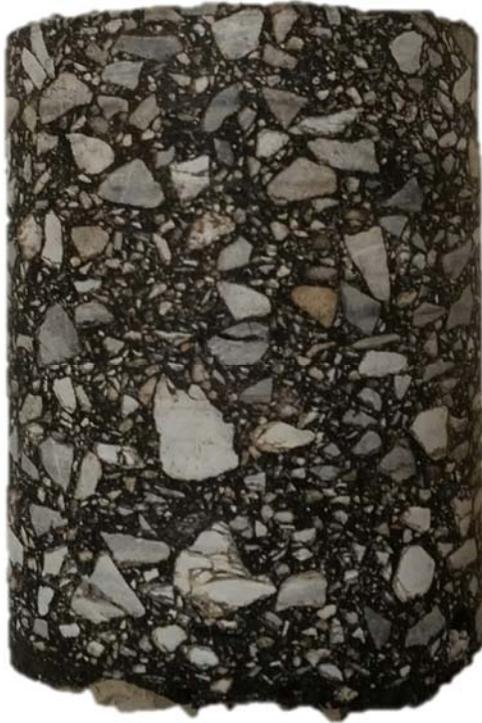
Photo of the 5 inch thick pavement core obtained at C-2 location

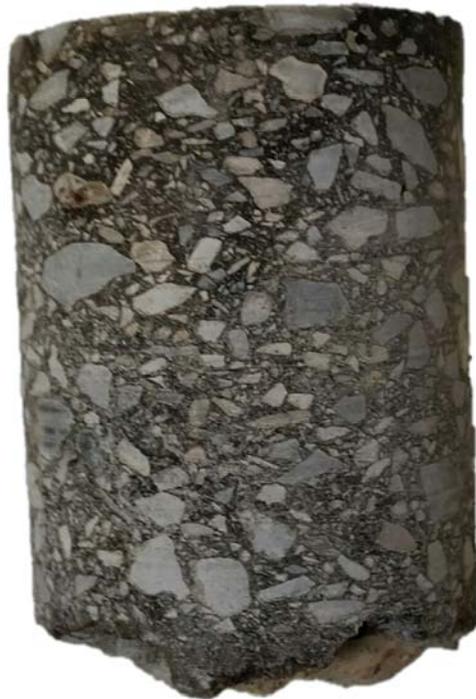
Photo of the 5 inch thick pavement core obtained at C-3 location
